Staff Responses to Council Questions March 22, 2016

L. Motion: Award a contract for the Design and Oversight for Parking Deck Rehabilitation and Maintenance to Walker Parking Consultants/Engineering, Inc. dba Walker Restoration Consultants, of Elgin, Illinois in an amount of \$42,460.00.

**MAINTENANCE PLAN &
CONDITION ASSESSMENT REPORT**
FOR THE:
DOWNERS GROVE PARKING GARAGE
MOCHEL DRIVE

Downers Grove, Illinois
April 23, 2015

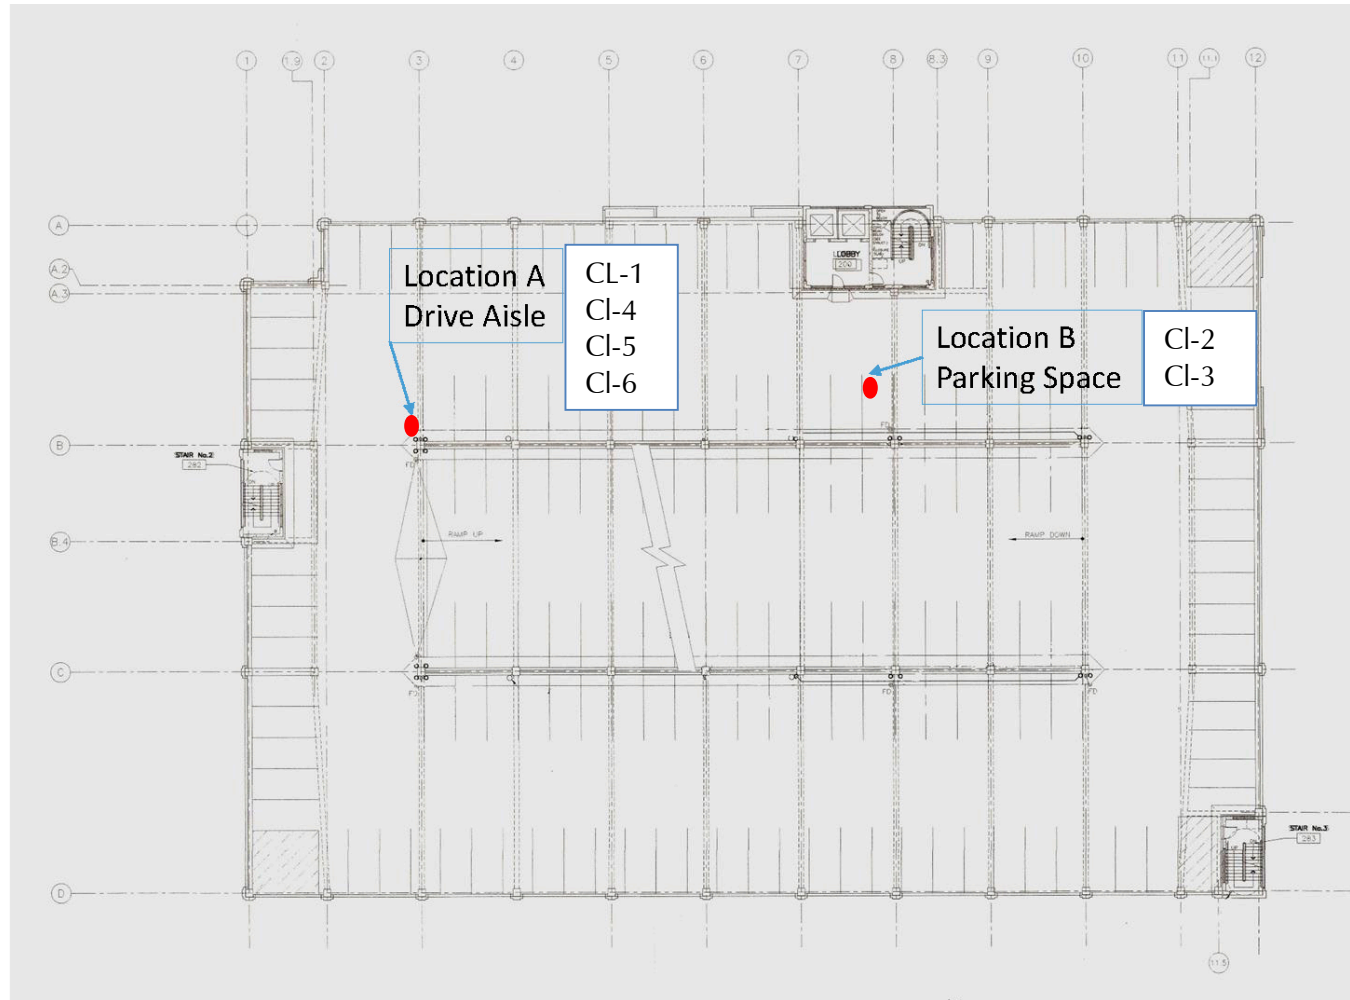
The chloride ion concentration at the estimated 2" to 3" depth of reinforcing steel is 68 ppm. This concentration is below the corrosion threshold (300 to 500 ppm). The reinforcing steel is therefore expected to be passive and protected from corrosion. Based on current chloride test data the expected service life until repairs are required in the floor slab is 30 to 50 years.

Location Key

- A – Level 5
- A – Level 3
- A - Level 2
- A – Level 1
- B – Level 5
- B – Level 4

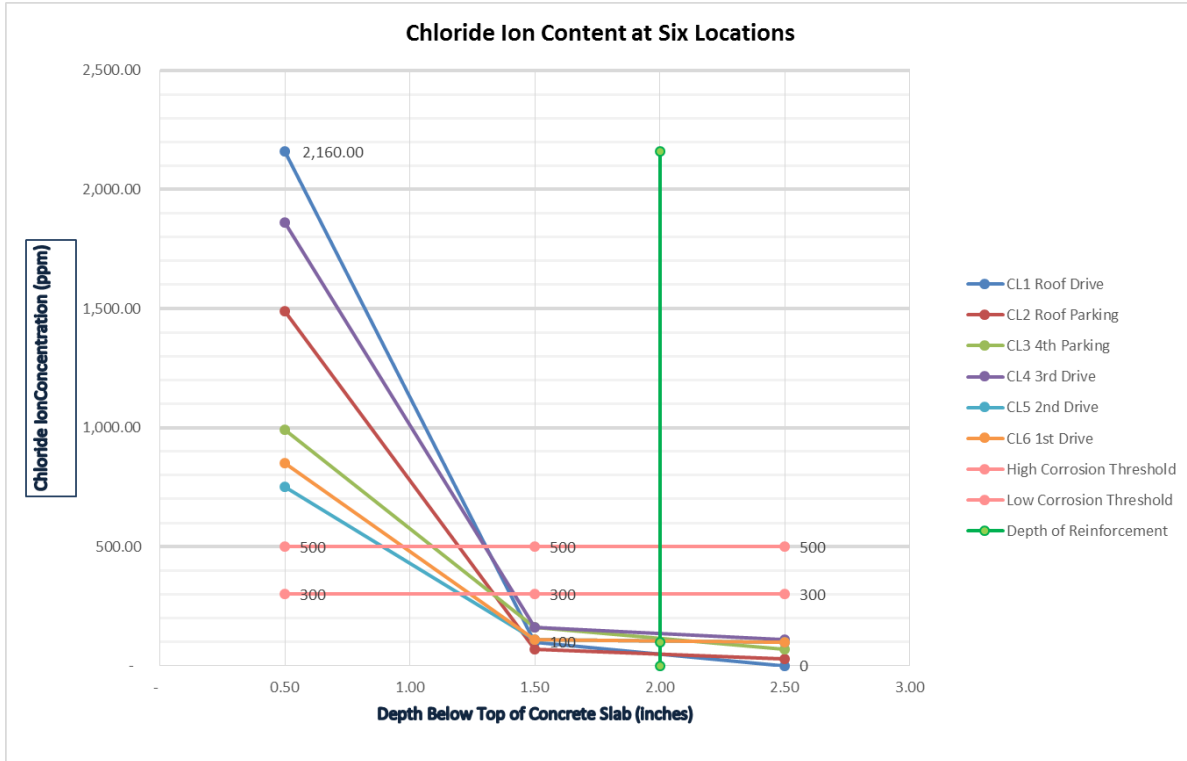
Figure B2 Graph of Chloride Ion Concentration Vs Depth Into Floor Slab

The uniformity of the chloride ion concentration in the second and third inch indicate the chlorides measured by the test were not from chlorides migrating from the top surface down. When chlorides migrate from the top down, the measured chlorides in the second inch would be lower than the top inch but higher than the bottom inch. In the testing completed all the test results in the 2" to 3" depth are about the same, indicating a background chloride content in the concrete. In the Chicago area the dolomite coarse aggregates commonly contains chlorides which generally have not caused durability issues in garages that are well maintained. The measured chloride concentrations are therefore adjusted by subtracting the estimated background chloride. The lowest measured chloride content (530 ppm) was used in the
