VILLAGE OF DOWNERS GROVE
Report for the Village Council Meeting
4/14/2015

SUBJECT:	SUBMITTED BY:
Discussion of Clyde Estates Design	Nan Newlon Director of Public Works

Clyde Country Estates Project Update

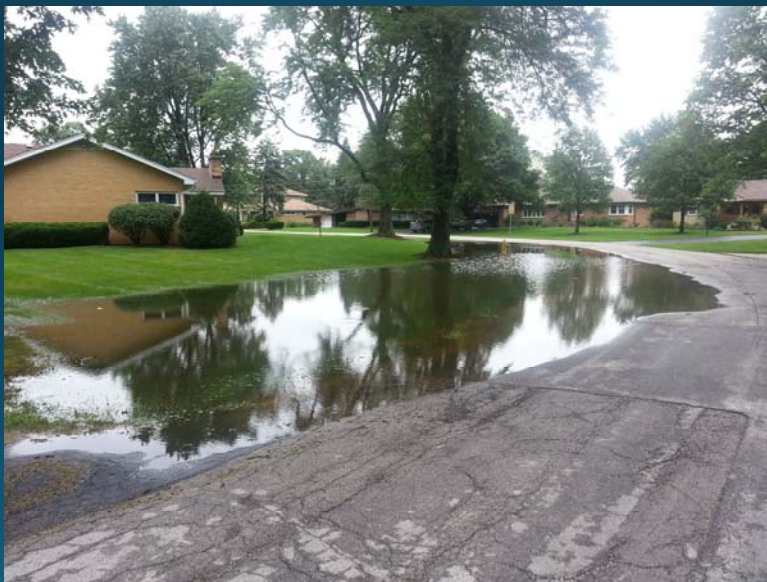
Parkway and Street Flooding on Clyde East of Washington

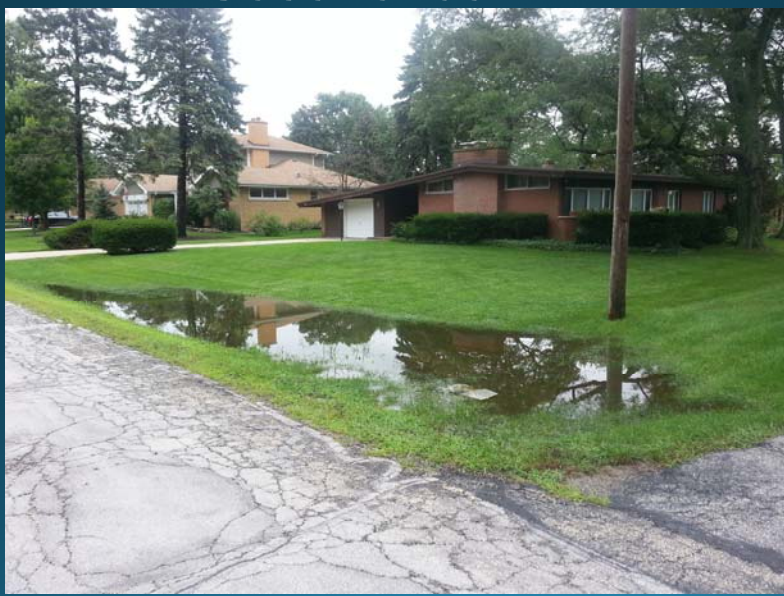
Parkway Flooding on Clyde South of 60th Pl

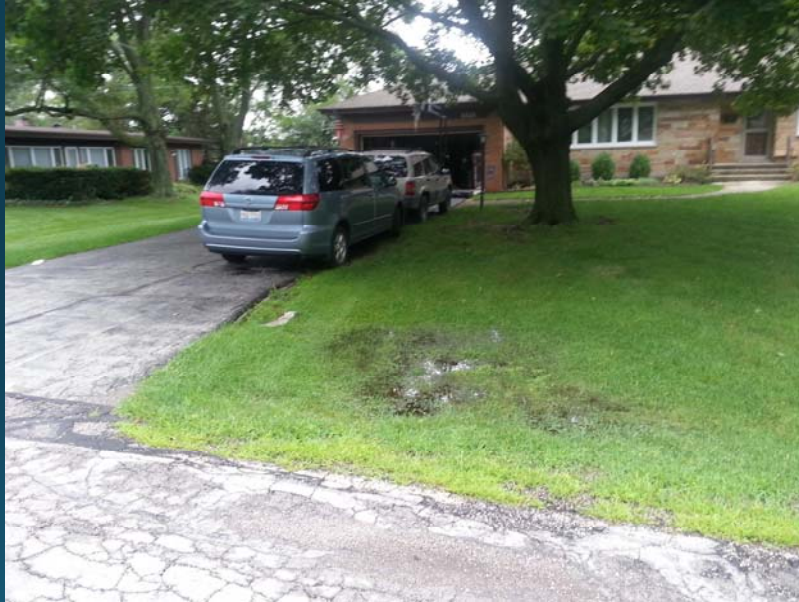
Common Soggy Parkway

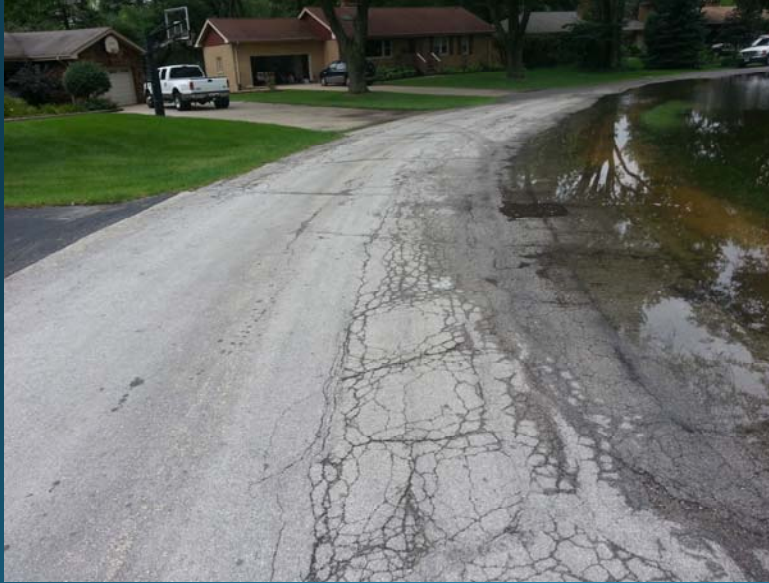
- Existing pavement condition is beyond the effective use of preventative maintenance
- Shows signs of base failure, especially in poorly drained areas
- Pavement edge throughout subdivision is rapidly deteriorating

Alligator Cracking (base failure)

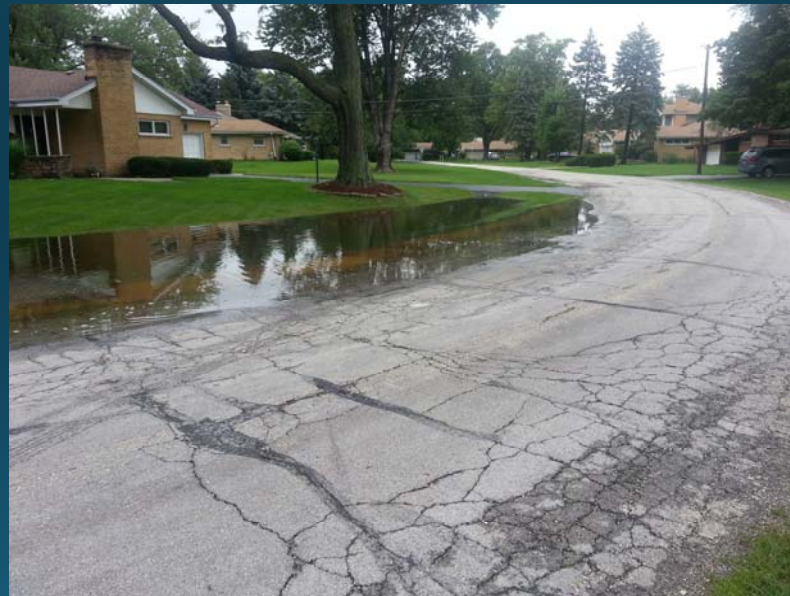
Alligator Cracking (base failure)

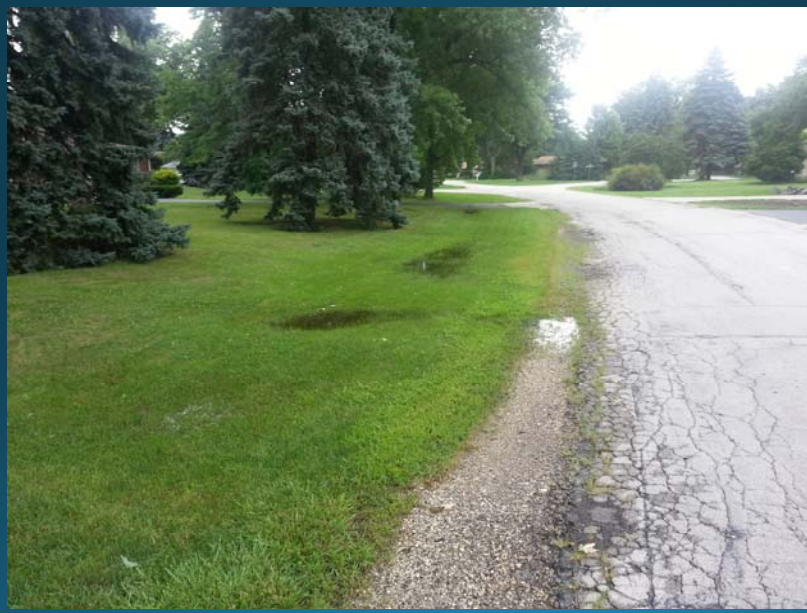
Deteriorating Edge

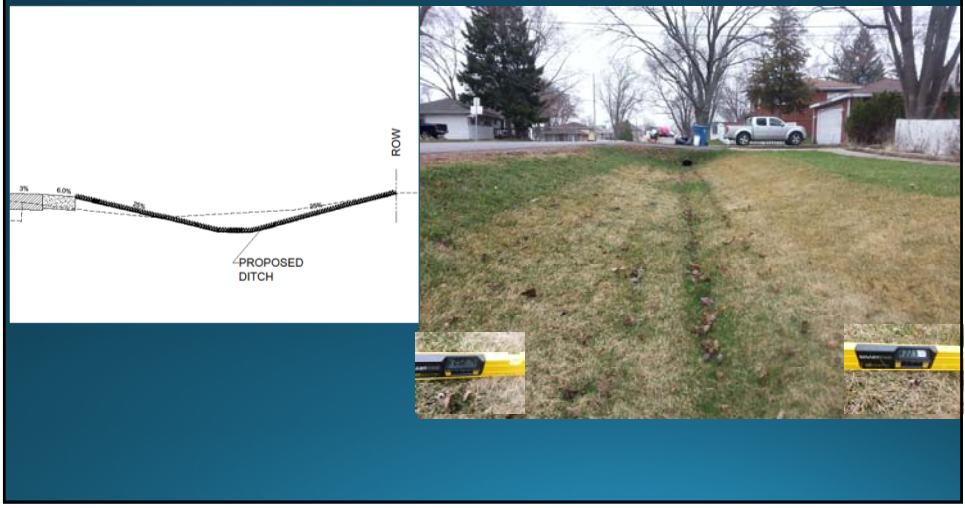
Non-standard ditch (depth >2.5')

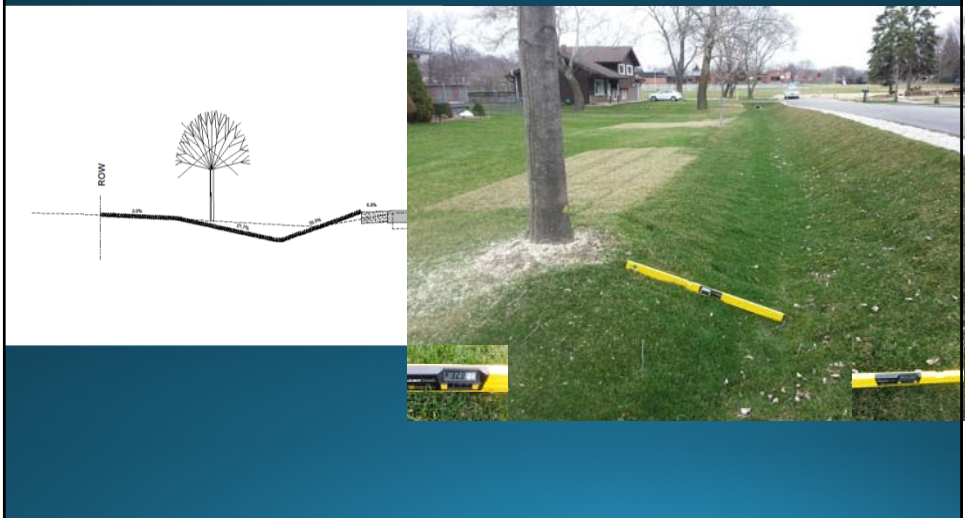
Non-standard ditch (slope > 4:1)
