**Staff Responses to Council Questions**  
**May 14, 2019**

**6. Consent Agenda, C. MOT 2019-8164 - 2019 Native Landscape and Natural Areas Maintenance and Monitoring**

## SECTION IV: PROJECT LOCATIONS

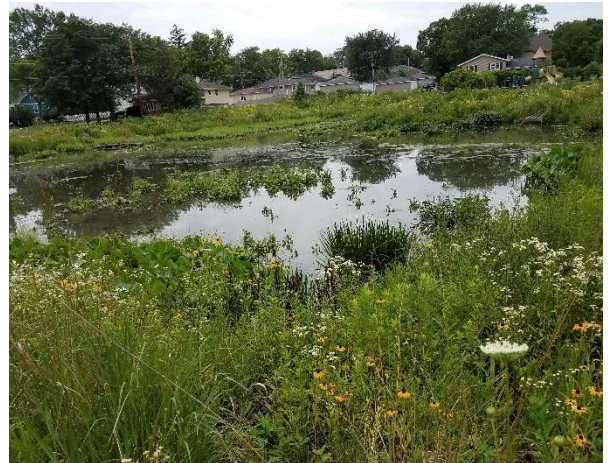
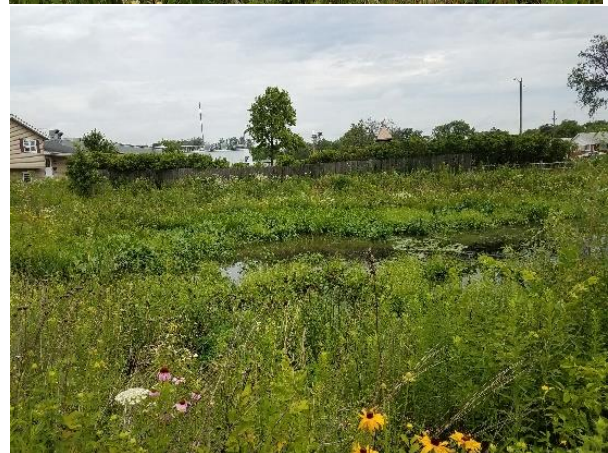
### 2<sup>nd</sup> and Cumnor Storm Water Facility (#2)

2<sup>nd</sup> and Cumnor is located along 2<sup>nd</sup> Street, adjacent to 2<sup>nd</sup> and Cumnor Park. This area consists of an open water wetland with a wide prairie buffer. A walking trail is located on the south and east portions of the site. In the northwest corner, a small landscaped area is managed beneath a redbud tree (*Cercis canadensis*). The wetland ecosystem is dominated by pickerelweed, American white water-lily, blueflag iris, blue vervain (*Verbena hastata*), and swamp rose mallow (*Hibiscus palustris*). The upland ecosystem is dominated by stiff goldenrod (*Solidago ptarmicoides*), big bluestem, pale coneflower, yellow coneflower (*Ratibida pinnata*), purple coneflower, sweet coneflower, wild bergamot (*Monarda fistulosa*), and black-eyed Susan (*Rudbeckia hirta*). Woody resprouts are treated each year but will require continuous management.

Overall, the site shows strong and diverse native character with many high quality species in both wetlands and prairies. With continued efforts to manage and suppress invasive species, these will continue to become less prominent. HLR recommends removal of woody saplings to prevent shade-out of herbaceous prairie plants. The saplings should be treated with herbicide and then cut. Bare areas where large patches of crown vetch (*Securigera varia*) were treated should be overseeded with a mesic to dry seed mix. General management of herbaceous non-natives should continue via herbicide application. Hand pulling of non-plugged species in the landscaped area should continue to ensure that little bluestem (*Schizachyrium scoparium*) is the only plant that populates the space. Native plants should be installed to increase coverage and choke out weeds in this area.

We performed herbicide treatments throughout the growing season to target various invasive species. These focused on biennials, such as purple loosestrife, thistle, and garlic mustard, which were present throughout the growing season. Various saplings, including Siberian Elm (*Ulmus pumila*), box elder (*Acer negundo*), and common buckthorn (*Rhamnus cathartica*), were also treated. In more established areas, hand weeding of invasive species such as garlic mustard (*Alliaria petiolata*) and crown vetch (*Securigera varia*) was used to minimize disturbance of native species. Future herbicide treatments will be necessary to continue managing problematic species. Certain areas of the path that became overgrown were trimmed back this year and will likely need to be cleared or pushed back to keep encroachment on the walking path to a minimum.

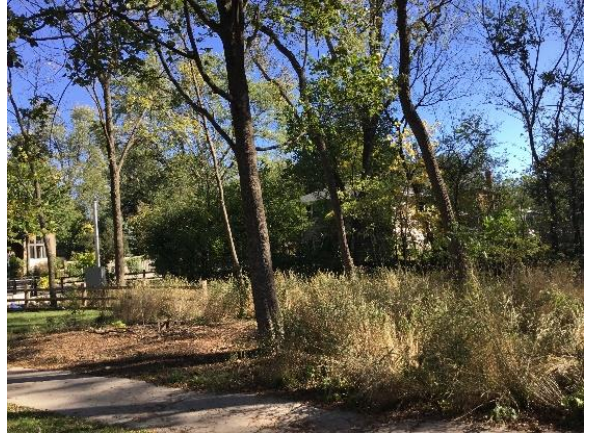
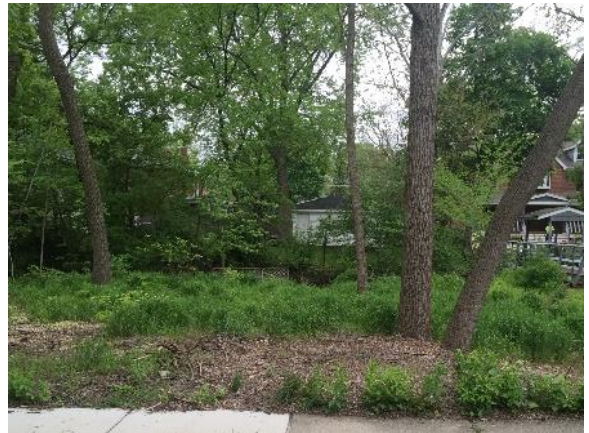
### Grand and Hill

Grand and Hill is located at the southeast corner of Grand Avenue and Hill Street. It consists of a small prairie/woodland area with a creek channel extending along the east side of the site. This natural area was cleared of invasive tree species (i.e. buckthorn) in February 2016 and is now dominated by stands of medium-sized trees that allow more sunlight in the understory. The site is dominated by native rye grasses and Virginia creeper, with some showy woodland species including King Solomon's seal (*Polygonatum canaliculatum*). Woody saplings along with pokeweed, giant ragweed, and wild lettuce are the most common undesirables.

HLR recommends that the woody saplings be herbicided and cut and for the herbaceous non-natives to receive herbicide treatments. Overseeding with a shade-tolerant prairie/woodland mix could help minimize bare spots, increase diversity, and enhance aesthetic appeal.

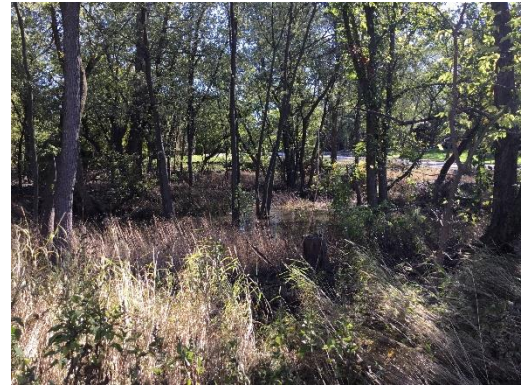
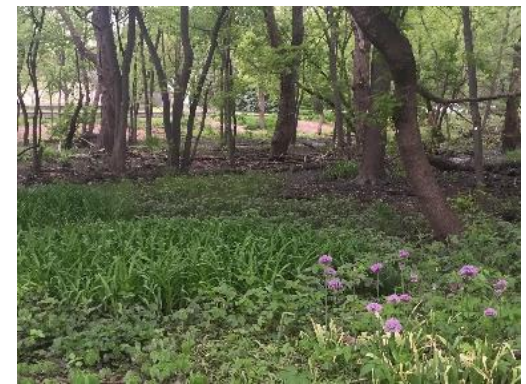
### Grand and 55<sup>th</sup>

Grand and 55<sup>th</sup> is located on the northeast corner of Grand Avenue and 55<sup>th</sup> Street. It consists of a depressional woodland with a creek channel extending diagonally through the site. This natural area was cleared of invasive tree species (i.e. buckthorn) in February 2016 and is now dominated by stands of medium-sized trees with lower shade potential. The majority of the site is composed of sparse herbaceous cover and a fair amount of buckthorn saplings. Virginia creeper (*Parthenocissus quinquefolia*), wild ginger (*Asarum canadense*), orange jewelweed (*Impatiens capensis*), and common blue violet (*Viola sororia*) are among the most common species present. Giant ragweed (*Ambrosia trifida*), great burdock (*Arctium lappa*), American pokeweed (*Phytolacca americana*), and wild lettuce (*Lactuca canadensis*) are among the most common weeds and non-native species found on site. The west side of the site is comprised of a tall prairie grass buffer.

HLR recommends continued general maintenance of invasive herbaceous species and woody saplings. A woodland seed mix could be installed to increase vegetative cover and compete with noxious weeds and non-natives that can take advantage of the exposed forest floor. To improve aesthetics, the upland buffer along the west side could be seeded with a diverse, shade-tolerant, prairie seed mix.

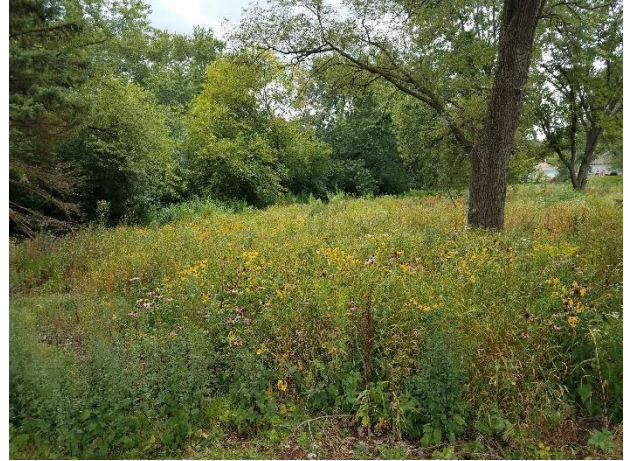
### Sterling Road North of 40<sup>th</sup> Street

Sterling is located at 3944 Sterling Avenue as a vacant lot. This area consists of a mixed woodland-prairie ecosystem and includes a diverse vegetative community. The southern boundary consists of a thick, shady tree line. The northern boundary is more typical of an open prairie and is adjacent to a residence. The east side of the area is also shaded and consists of common buckthorn (*Rhamnus cathartica*) and amur honeysuckle (*Lonicera maackii*) saplings. A plethora of high quality species can be found at Sterling, including side-oats grama (*Bouteloua curtipendula*), pale coneflower, sweet coneflower (*Rudbeckia subtomentosa*), and golden Alexander (*Zizia aurea*). Common non-native and undesirable species also exist here, including garlic mustard (*Alliaria petiolata*) and Canada thistle.

This site is a turf grass conversion area completed by HLR. In summer 2015, it received herbicide treatments to eradicate broadleaf woody species and turf grass. A custom seed mix was installed in late fall. Native management of the site began in 2016. The site received two herbicide treatments during the summer targeting weedy invasive species such as thistle and garlic mustard. In the fall, two visits were devoted to buckthorn removal and stump treatments. Continued removal efforts and management of these invasive species will be necessary to complete the conversion to a naturalized area. Additional removal of woody species will allow more woodland natives to establish along the south and west sides of the property. HLR recommends routine herbicide application to weedy and invasive species, including both herbaceous plants and woody saplings. The shaded areas that have lower herbaceous cover (south and east boundaries) should be overseeded with a shade-tolerant mix.

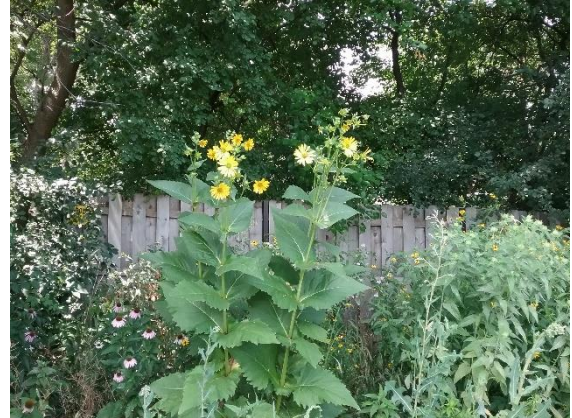
### Fire Station Bioswale

Fire Station is located along the west side of the Downers Grove Fire Station #3 parking lot, at the intersection of Main Street and 39<sup>th</sup> Street. The site consists of a rain garden style strip that is composed of species ranging in wetland indicator statuses. Purple coneflower (*Echinacea purpurea*) and pale coneflower (*Echinacea pallida*) can be seen in the upland areas while blueflag iris (*Iris virginica shrevei*) can be found in the north lower elevation corner where a drainage way exists. In mid-September, New England aster (*Aster novae-angliae*) and prairie cord grass (*Spartina pectinata*) plugs were installed to enhance bare areas. Regrowth of woody saplings including green ash (*Fraxinus pennsylvanica*), white mulberry (*Morus alba*), and box elder (*Acer negundo*) have been treated but will require continuous management.

Following the construction and previous management of the bioswale by others, we assumed management in 2016. The site was managed with three herbicide treatments and one hand weeding. Many of the native species are forming thick stands which will suppress invasive growth. Continued management of weedy species, particularly reed canary grass (*Phalaris arundinacea*) and thistle, will be necessary to ensure successful establishment of the naturalized bioswale. Some of the more aggressive native species may need to be managed to maintain diversity. HLR recommends woody sapling removal and continued herbicide treatment of herbaceous invasives. Low coverage areas should be over seeded with custom native seed mixes for the upland and wetland areas as needed.

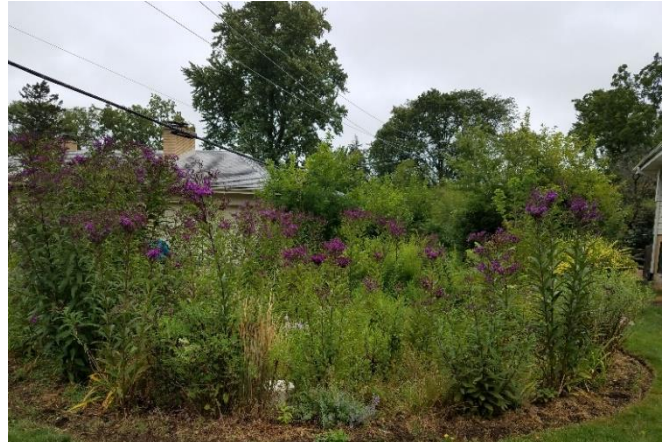
### 59<sup>th</sup> and Washington Street Bio-Retention Facility

This site is an under-drained bio-retention facility, currently dominated by native forbs and grasses, located between two residential lots.

Several quality species are present, including iris, wild bergamot and goldenrod; however, vegetation is still fairly sparse in some locations. An over-seed mix will be formulated to encourage more diverse growth while filling in these sparse areas. Cutting back dead vegetation during the off season will allow additional sunlight to reach the soil surface, giving new seed a chance at establishment. Though the apparent count was already low, the treatment and removal of weedy invasive species such as foxtail (*Bromus madritensis*), wild carrot (*Daucus carota*), and penny cress (*Thlaspi arvense*) will provide additional support for this system.

This area is subject to accumulate an abundance of leaf litter and debris from neighboring lots. The collection of debris will require monitoring and frequent clearing to maintain aesthetics while keeping unnecessary elements out of water flowing out of the system during heavy rain events.

The previous year's vegetative litter was cut and removed to present a neater appearance. Following this, the site was hand weeded three times, including all invasive species and cultivars. The site has maintained high levels of species quality and diversity through the season. Invasive species were minimal and easily managed. The basin may require seasonal clearing as necessary to maintain aesthetics. We also installed mulch around the rain garden to provide a visual border.

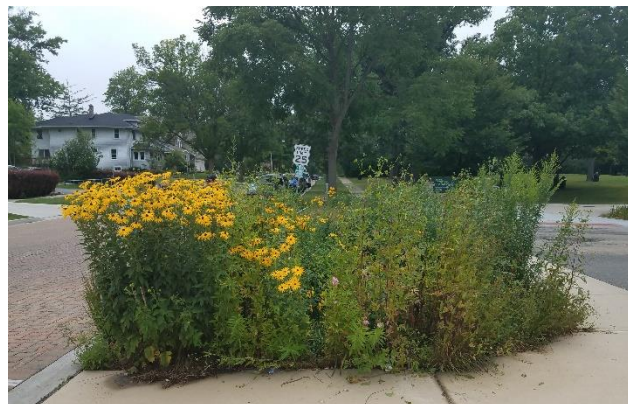
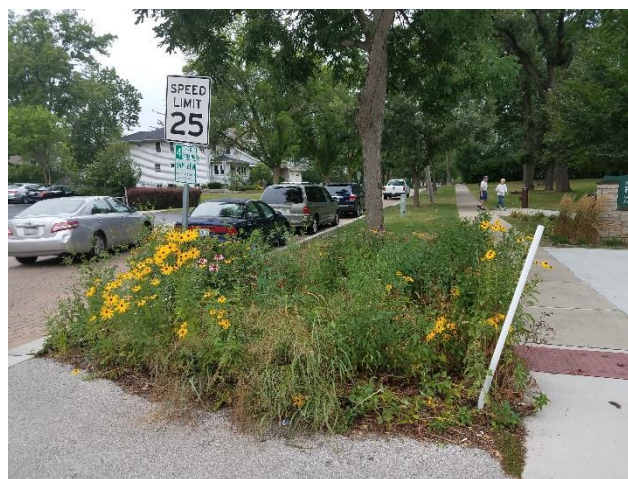
### Grove Street Rain Gardens

These areas are subject to extensive debris collection from the surrounding streets and sidewalks and show signs of heavy disturbance from car and foot traffic exiting the lot. This poses multiple obstacles in the successful establishment of a healthy community in such a small area. Despite this, a variety of healthy natives appear present onsite, still requiring a little help through additional plantings, weeding, and debris pickup. Our team would like to use the Village’s mulch stockpile for this site. Mulch will be picked up and spread by HLR.

Within the central portions of these two planted areas lies the greatest concentration of healthy natives, fulfilling their role as a stabilizing filtration mechanism within the rain garden. However, the perimeter of these rain gardens are primarily old mulch with little to no present vegetation, with the exception of the eastern most edge of the eastern rain garden. Increasing the presence of planting material strengthens the effect of these designated areas, utilizing the entire section to collect and filter rain water while providing as much aesthetic appeal as possible.

Damage by vehicle traffic was evident during our site inspection. The edges of these gardens, directly butting up against the drive, would benefit from the planting of short native grasses, such as Little Bluestem, complimentary to those already in place, to sway traffic away from the planted area. During the winter season when snowfall is abundant, fiberglass reflector rods may be necessary to direct traffic away from the otherwise hidden rain gardens.

HLR has managed the Grove Street Rain Gardens since 2014. Hand-weeding has been a successful management tool and was completed six times throughout the season. The planted areas exhibit significant native character. Early in the season, the dead vegetation was cut, raked, and taken off-site to maintain aesthetics. This will be necessary in the future to maintain a neat appearance for the naturalized area. Several of the taller species, such as wild golden glow (*Rudbeckia lacinata*), were removed to improve vision lines for parking lot and street traffic. Installation of a split rail fence would prevent snow plow damage and may provide a more organized appearance to community stakeholders. Per the RFP, we will remove plants greater than 30” in height and replace them with shorter plants to be approved by the Village prior to installation.

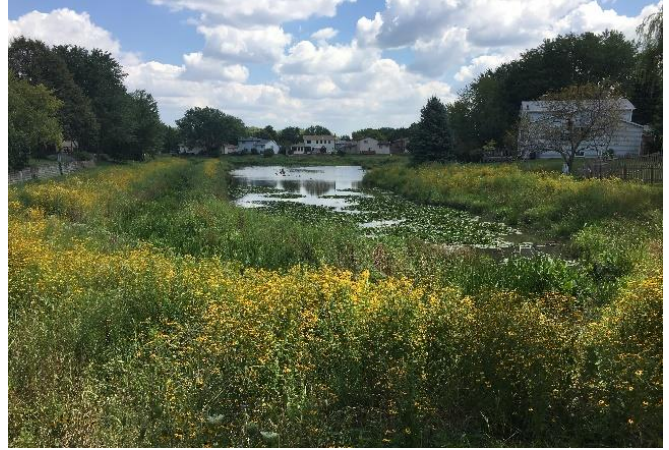
### Valley View Pond

Valley View Pond is located behind Valley View Drive, from Foster Place to Waterfall Place. This area consists of a large open water pond with a gradual shoreline and wide prairie buffer. Plant communities include emergent, shoreline, wet mesic prairie, and mesic prairie. A drainage channel extends along the north section of the site. A berm is located between the channel and the pond. Emergent vegetation, including blueflag iris, common arrowhead (*Sagittaria latifolia*), and broad-fruit bur-reed (*Sparganium eurycarpum*), can be found in both the channel and the pond. A small group of yellow pond-lily (*Nuphar advena*) and American white water-lily (*Nymphaea odorata*) can be found at the west side of the pond. Vegetation within the shoreline zone includes dark green bulrush (*Scirpus atrovirens*), river bulrush (*Schoenoplectus fluviatilis*), and prairie cordgrass. The prairie buffer and berm support a diverse group of native species, including big bluestem (*Andropogon gerardii*), red columbine (*Aquilegia canadensis*), tall boneset (*Eupatorium altissimum*), saw-tooth sunflower (*Helianthus grosseserratus*), and foxglove beardtongue (*Penstemon digitalis*). A turf grass path was seeded along the southern site boundary and was poorly established. It is especially susceptible to common weedy species such as Canada thistle. Purple loosestrife (*Lythrum salicaria*), a particularly aggressive wetland invasive species, can be found throughout the site.

Since 2014, HLR has monitored this area. Native plant communities around the pond are well established, but will require routine maintenance to prevent encroachment of invasive and woody species and maintain existing floristic diversity. The narrow bentgrass transition zone around the native plantings will also need routine management to maintain vegetation at the desired height and to prevent establishment of undesired species. We offer the following recommendations for long-term maintenance activities. Site conditions will dictate frequency and intensity.

- Continue periodic herbicide treatments targeting non-native and invasive species including cattail (*Typha* spp.), purple loosestrife (*Lythrum salicaria*), sandbar willow (*Salix interior*), thistle (*Cirsium* spp.), teasel (*Dipsacus* spp.), common reed (*Phragmites australis*), curly dock (*Rumex crispus*), tall boneset (*Eupatorium altissimum*) and woody species.
- Perform a winter mowing to promote native species and hinder non-native species, as needed.

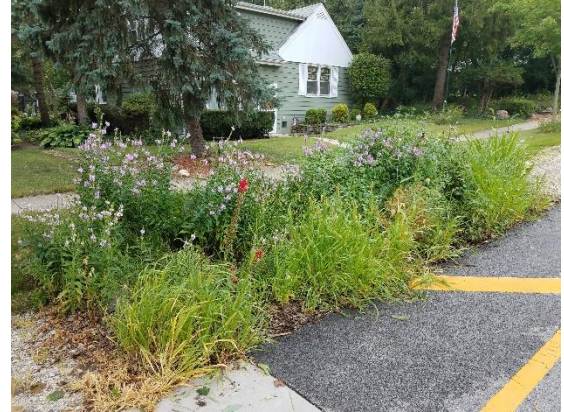
### Forest Avenue Rain Gardens

Forest Avenue Rain Gardens are located along Forest Avenue between Herbert Street and 41<sup>st</sup> Street. The site consists of three small rain gardens, two on the west side of the street and one on the east side. All three have similar vegetative composition; obedient plant (*Physostegia virginiana*) appears to be the most dominant followed by eastern woodland sedge (*Carex blanda*) and common fox sedge (*Carex stipata*). Field sow thistle (*Sonchus arvensis*) and Canada thistle (*Cirsium arvense*) have been removed from the sites. However, it appears the soil has invasive seeds in the seed bank and will require continual management.

The site was managed in 2016 with two hand weeding treatments and one herbicide application. Minimal invasive species are present within the site. Continued management of prevalent weedy species will be necessary to maintain the existing species quality and diversity which are present. The site may benefit from seasonal clearing to present a neat appearance. Resident mowing has been an issue for two of the rain gardens. Per the RFP, the scope will include coordination with the existing homeowners in conjunction with Village staff to re-establish the two southern locations. HLR recommends continued hand-pulling of invasive and weedy species. Native plugs with showy and deep-rooted species would enhance aesthetics and improve rainwater infiltration. Signage is recommended to educate residents about the flood reduction feature of the rain gardens.

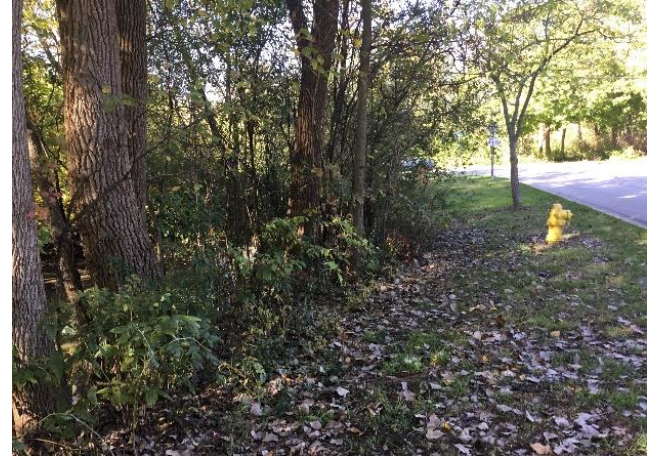
### Deer Creek

Deer Creek is located on the north slope of Saint Joseph Creek between Fairview Avenue and Deerpath Lane, to the roadside of 56<sup>th</sup> Street. The dominant herbaceous species along the slope include common ragweed (*Ambrosia artemisiifolia*), reed canary grass, and pokeweed. Large amounts of buckthorn, white mulberry, box elder, and honeysuckle are also present along the slope. The area between the slope and the curb of 56<sup>th</sup> street consists of turf grass that should be converted to a low growing prairie mix as to not restrict visibility from the adjacent road.

1. Removal of woody species including mulberry, box elder, honeysuckle, and buckthorn. Removal of these invasive species will allow more light to penetrate to the slope, allowing herbaceous species to stabilize the slope.
2. Herbicide the existing turf grass and heavy overseeding of the area is recommended.
3. Continued maintenance of the area would consist of herbicide treatments for any woody regrowth and herbicide and mechanical removal of invasive species within the prairie.
4. We recommend installing shrubs within the slope, such as common buttonbush (*Cephalanthus occidentalis*) or elderberry (*Sambucus canadensis*).
